# Guam Waterworks Authority (VP0989)

## CWA Collection System

Tumon, Guam

NEIC Field Investigation Photographs  
April 24 through May 4

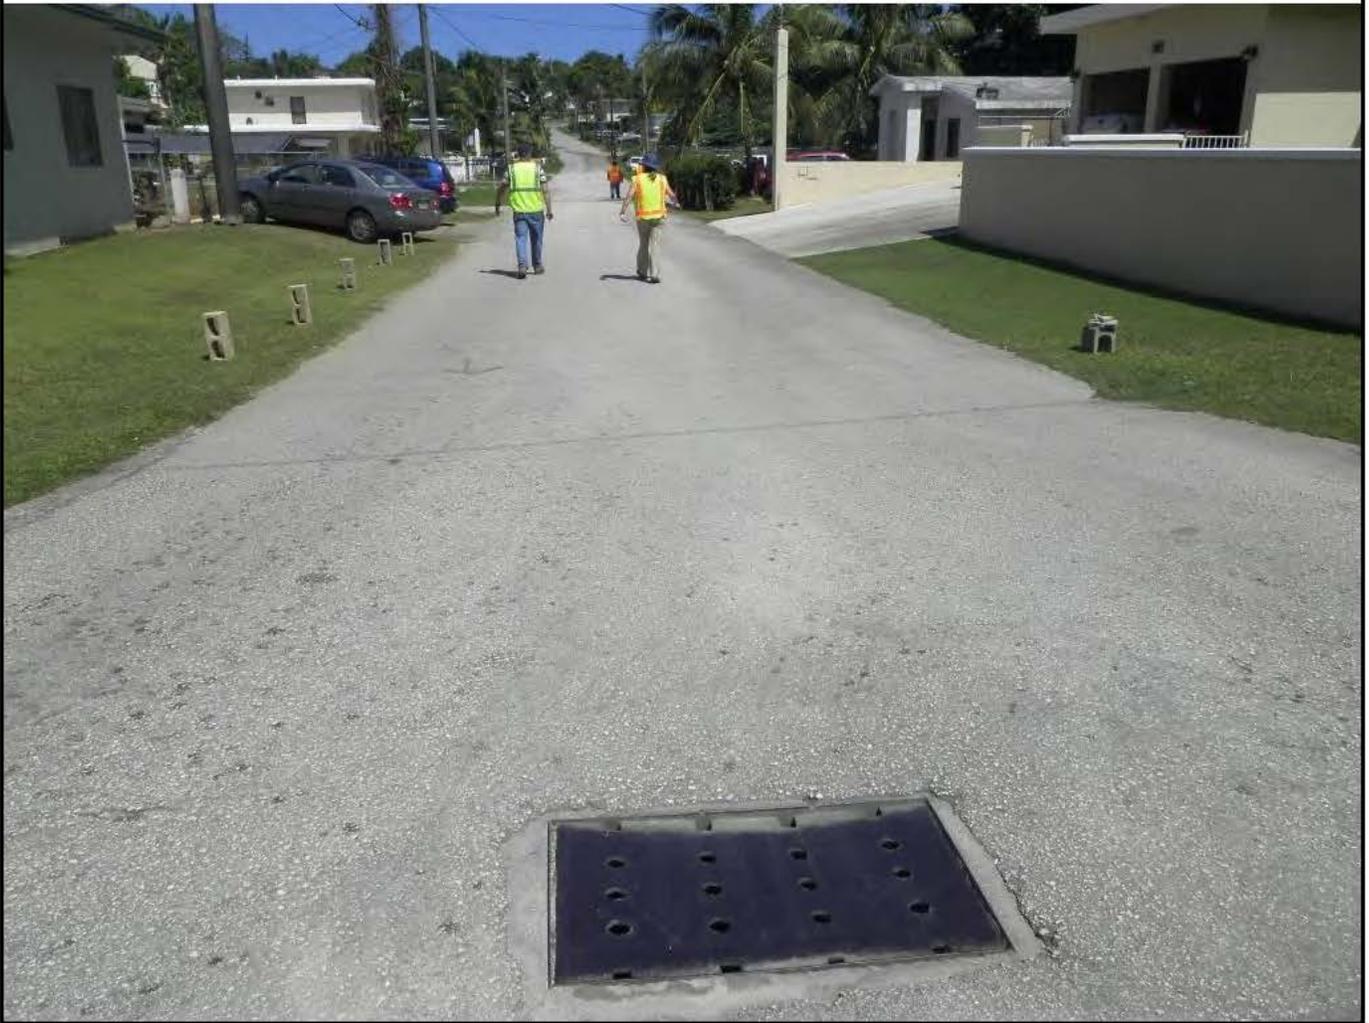
File Name: RIMG0067.JPG

Title	Guam Waterworks Authority (VP0989)
Subject	CWA Collection System
Date Time Stamp	4/30/2012 10:03:43 AM
Photographer	D. Vanlerberghe
Description	Storm drain near Agana Heights ponding basin

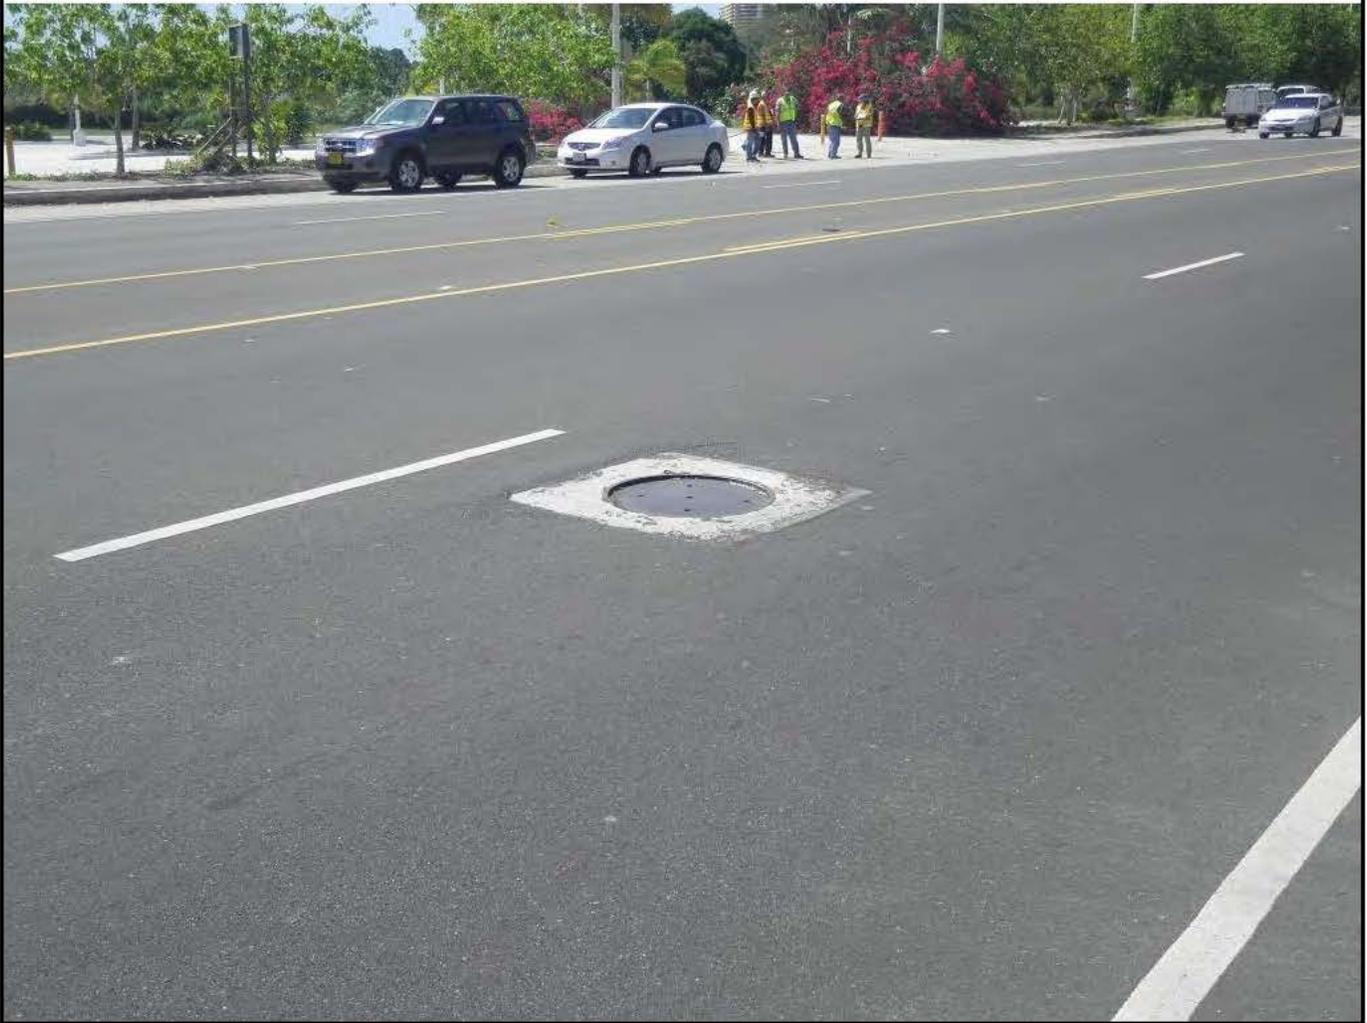
File Name: RIMG0068.JPG

<b>Title</b>	Guam Waterworks Authority (VP0989)
<b>Subject</b>	CWA Collection System
<b>Date Time Stamp</b>	4/30/2012 10:18:26 AM
<b>Photographer</b>	D. Vanlerberghe
<b>Description</b>	Manhole in Route 4, downstream of New Chaot pump station. Frequent overflows occur from this manhole due to pipe capacity and operational issues at the New Chaot pump station.

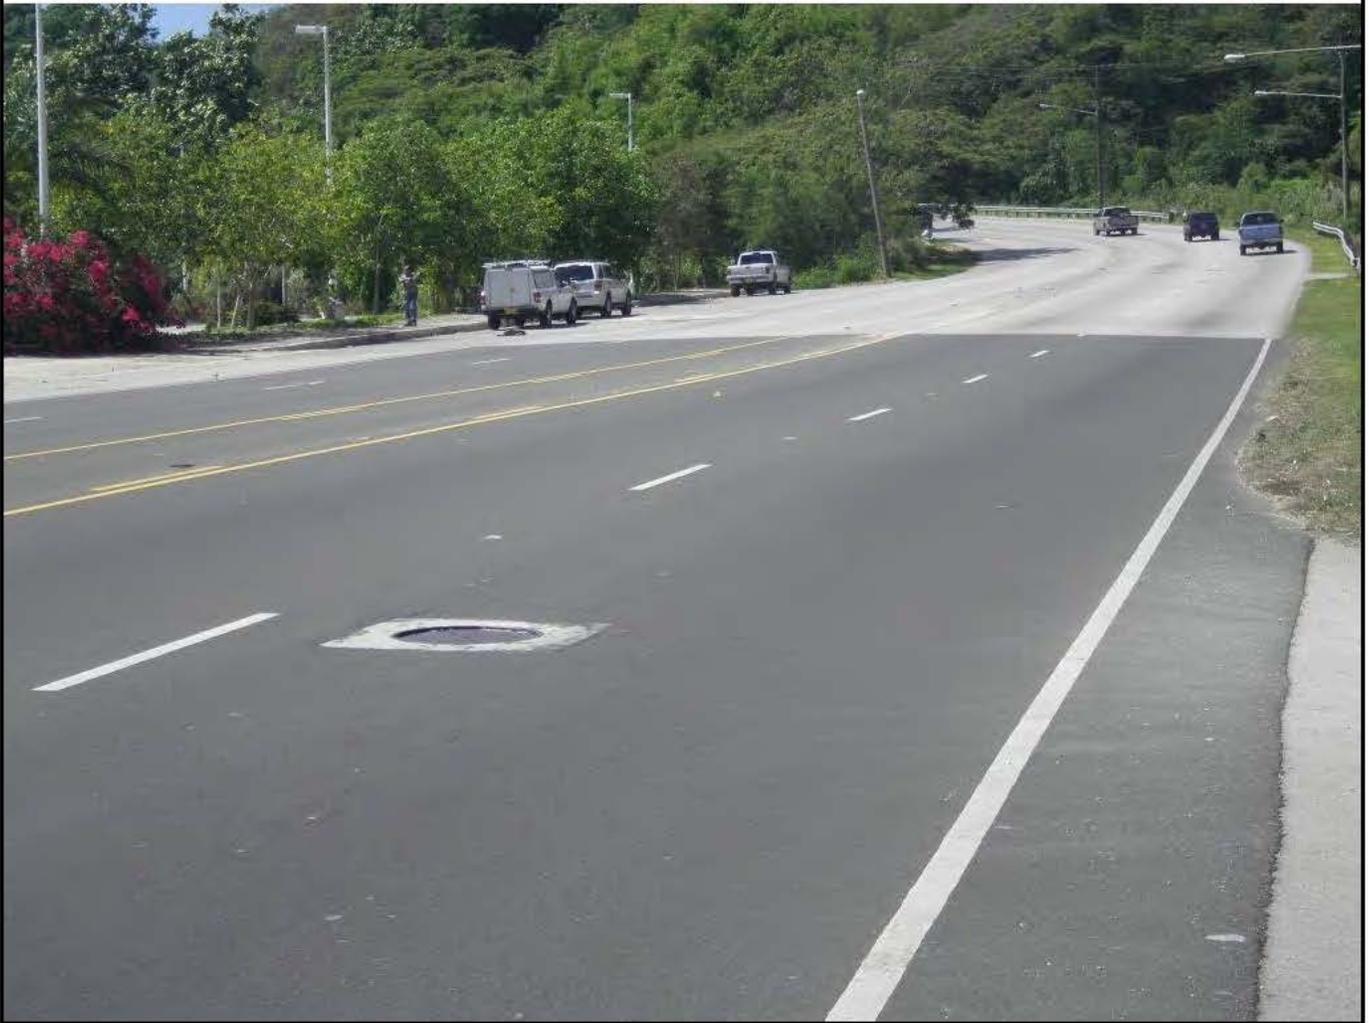
File Name: RIMG0069.JPG

<b>Title</b>	Guam Waterworks Authority (VP0989)
<b>Subject</b>	CWA Collection System
<b>Date Time Stamp</b>	4/30/2012 10:18:43 AM
<b>Photographer</b>	D. Vanlerberghe
<b>Description</b>	Manhole in Route 4, downstream of New Chaot pump station. Frequent overflows occur from this manhole due to pipe capacity and operational issues at the New Chaot pump station.

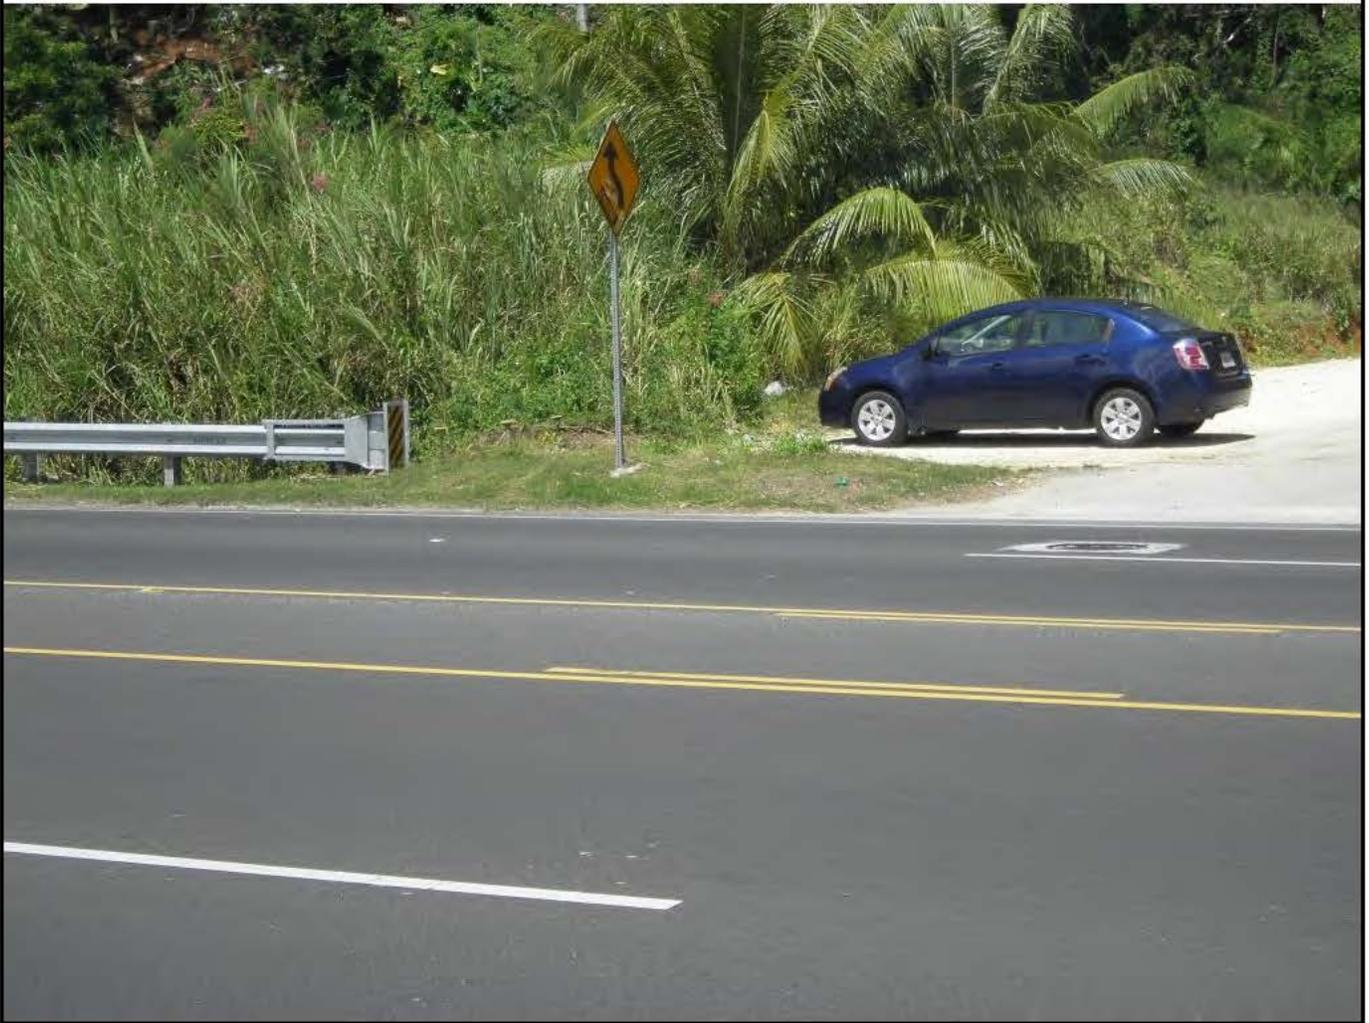
File Name: RIMG0070.JPG

<b>Title</b>	Guam Waterworks Authority (VP0989)
<b>Subject</b>	CWA Collection System
[REDACTED]	[REDACTED]
[REDACTED]	[REDACTED]
<b>Date Time Stamp</b>	4/30/2012 10:21:07 AM
<b>Photographer</b>	D. Vanlerberghe
<b>Description</b>	Manhole in Route 4, downstream of New Chaot pump station. Frequent overflows occur from this manhole due to pipe capacity and operational issues at the New Chaot pump station.

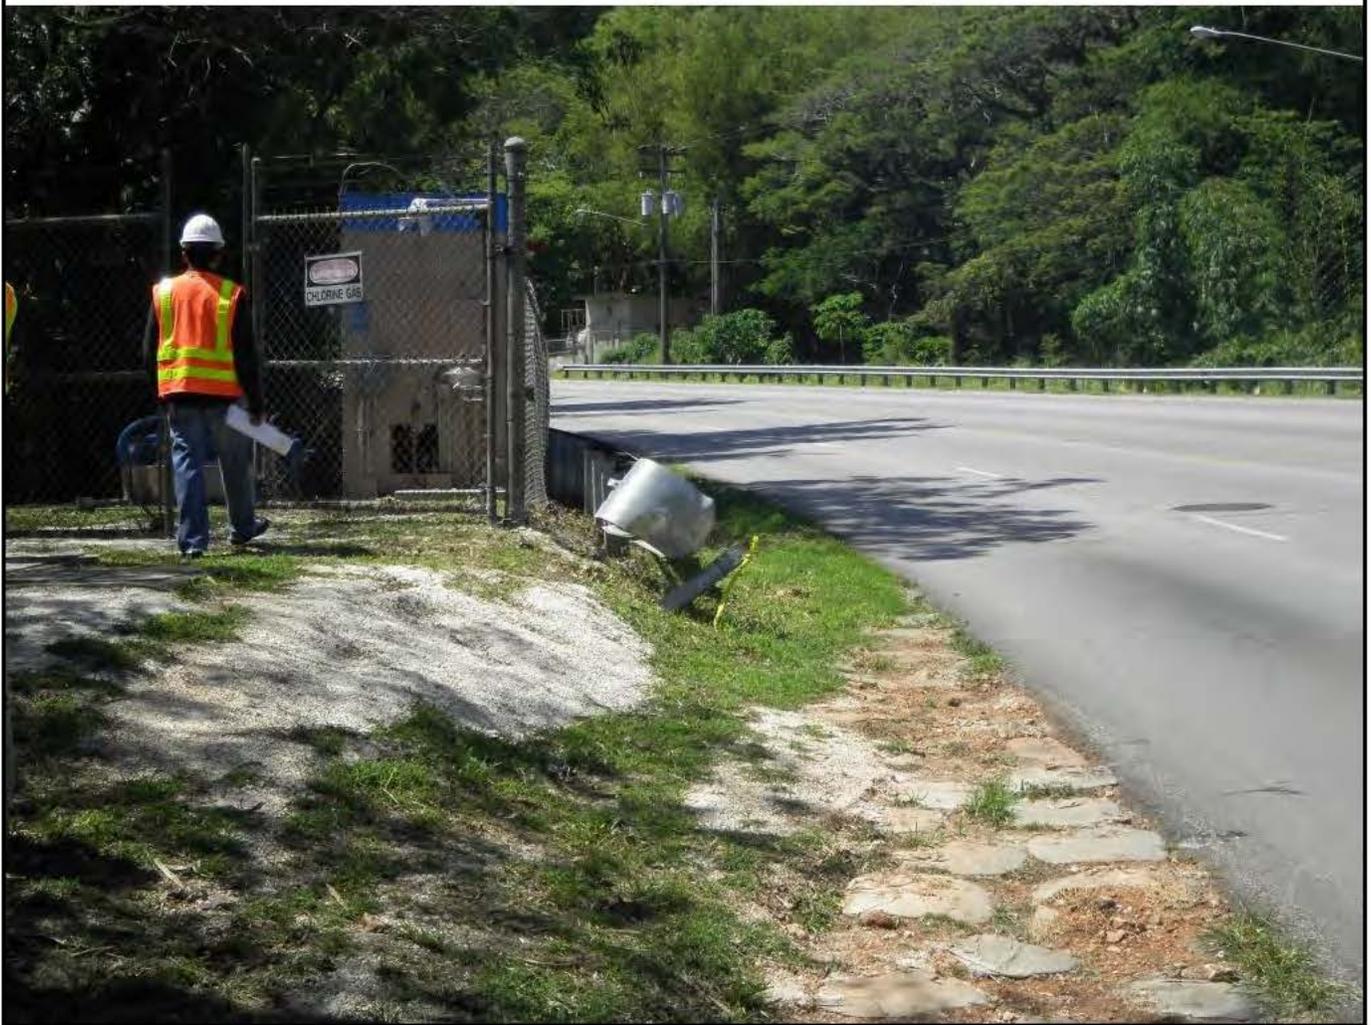
File Name: RIMG0071.JPG

Title	Guam Waterworks Authority (VP0989)
Subject	CWA Collection System
Date Time Stamp	4/30/2012 10:28:06 AM
Photographer	D. Vanlerberghe
Description	Manhole in Route 4 adjacent to water well A-23

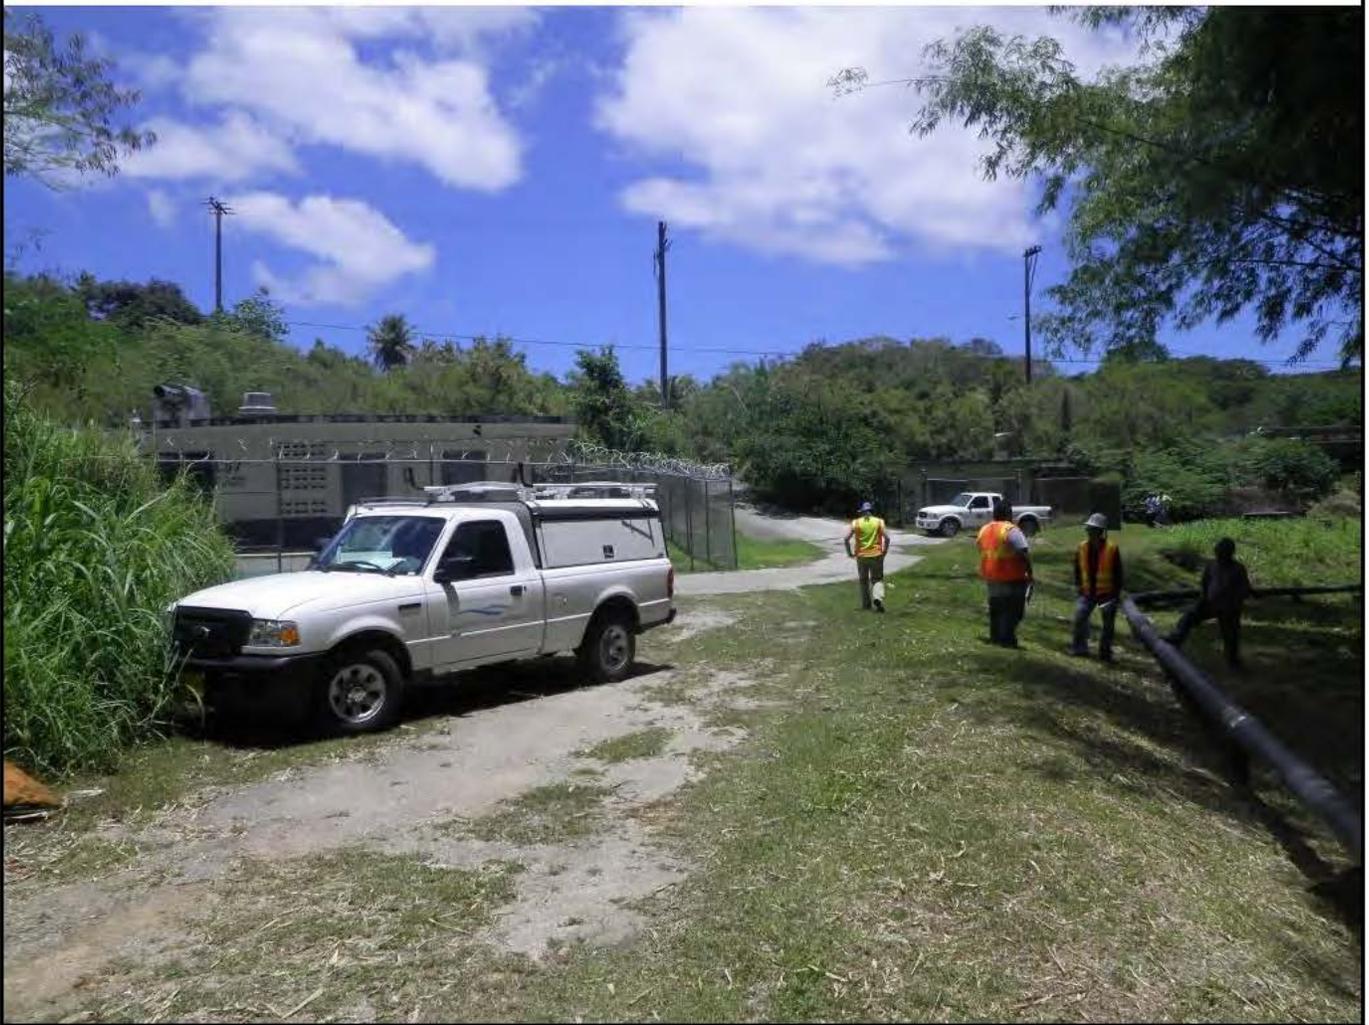
File Name: RIMG0072.JPG

Title	Guam Waterworks Authority (VP0989)
Subject	CWA Collection System
Date Time Stamp	4/30/2012 12:41:21 PM
Photographer	D. Vanlerberghe
Description	Old (background) and New (foreground) Chaot pump stations, showing adjacent fuel line on the right. The Old Chaot pump station is no longer in service.

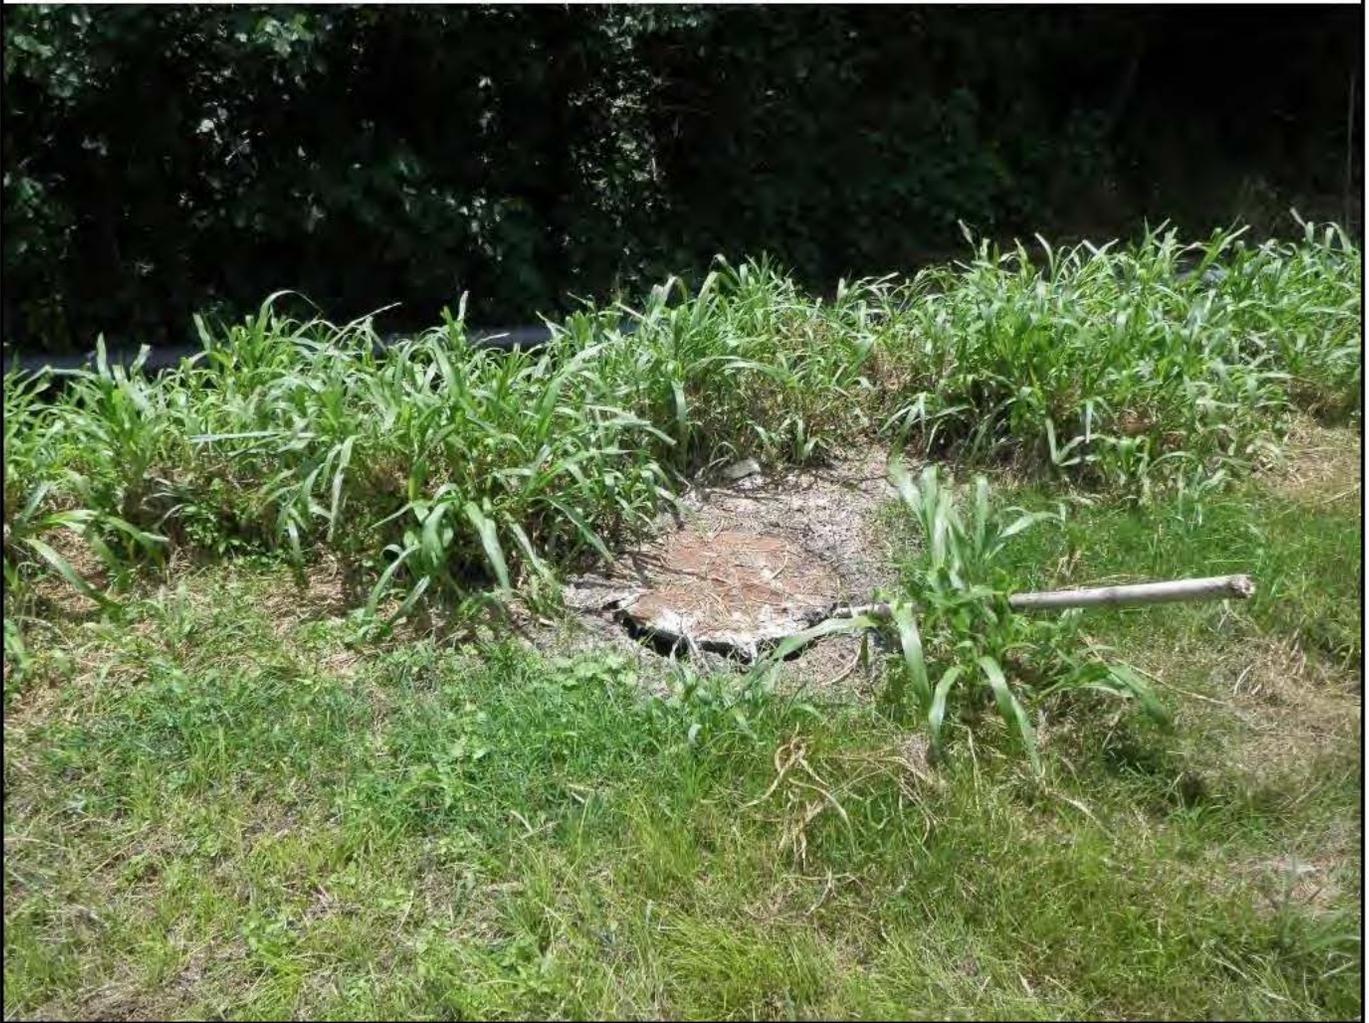
File Name: RIMG0073.JPG

Title	Guam Waterworks Authority (VP0989)
Subject	CWA Collection System
Date Time Stamp	4/30/2012 12:43:27 PM
Photographer	D. Vanlerberghe
Description	Manhole adjacent to New Chaot pump station and unnamed stream ditch on incoming pipeline to pump station. The manhole lid was open with sign of debris and overflow from the manhole towards the unnamed stream ditch.

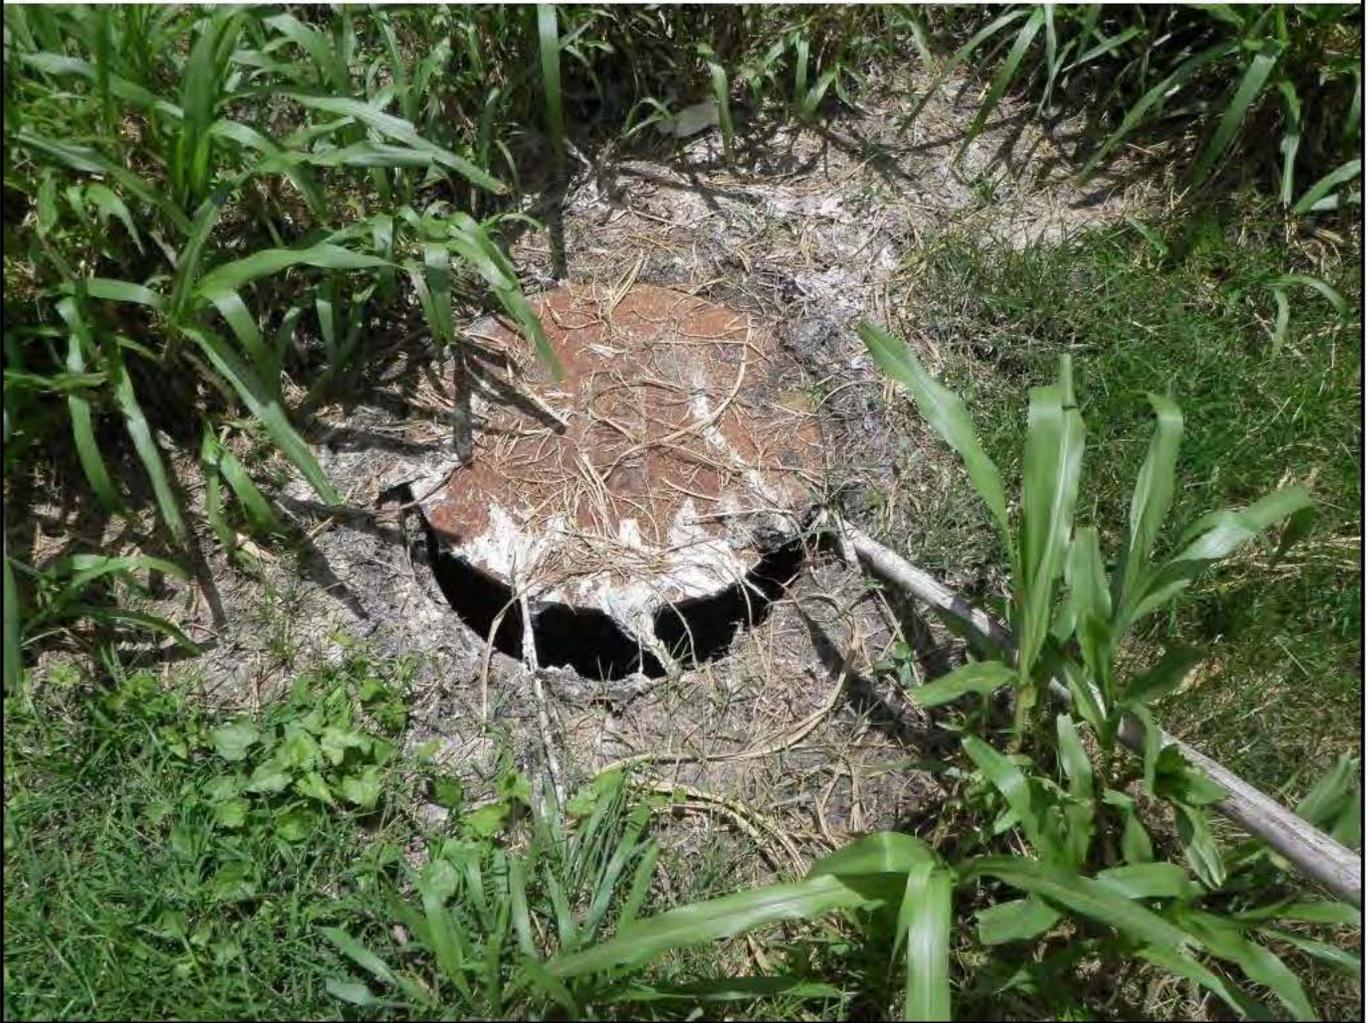
File Name: RIMG0074.JPG

Title	Guam Waterworks Authority (VP0989)
Subject	CWA Collection System
Date Time Stamp	4/30/2012 12:44:52 PM
Photographer	D. Vanlerberghe
Description	Manhole adjacent to New Chaot pump station and unnamed stream ditch on incoming pipeline to pump station. The manhole lid was open with sign of debris and overflow from the manhole towards the unnamed stream ditch.

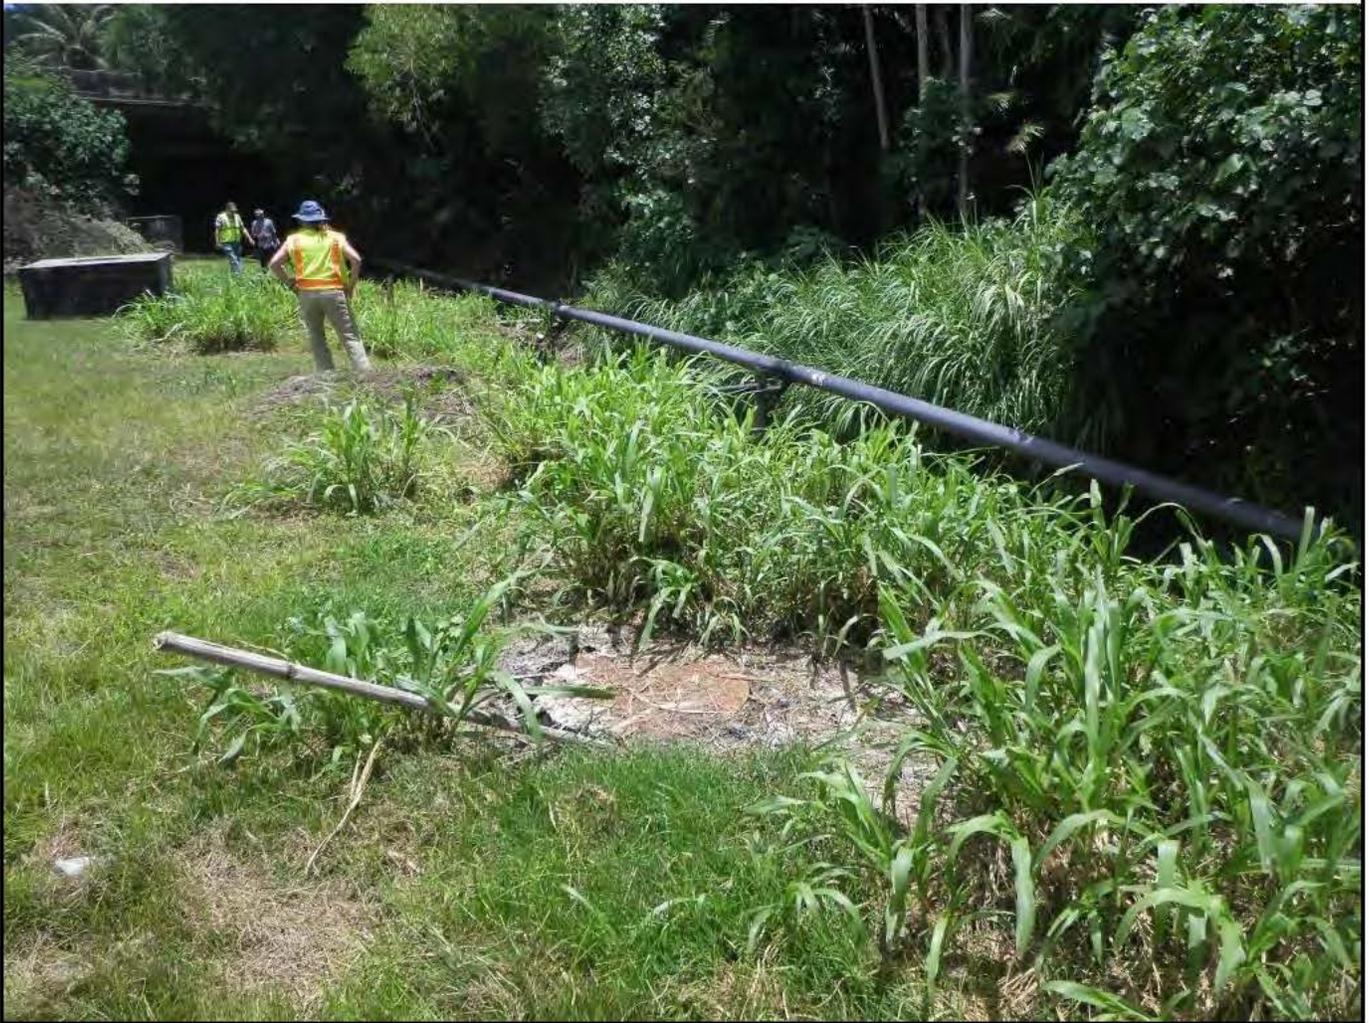
File Name: RIMG0075.JPG

<b>Title</b>	Guam Waterworks Authority (VP0989)
<b>Subject</b>	CWA Collection System
<b>Date Time Stamp</b>	4/30/2012 12:45:50 PM
<b>Photographer</b>	D. Vanlerberghe
<b>Description</b>	Manhole adjacent to New Chaot pump station and unnamed stream ditch on incoming pipeline to pump station. The manhole lid was open with sign of debris and overflow from the manhole towards the unnamed stream ditch.

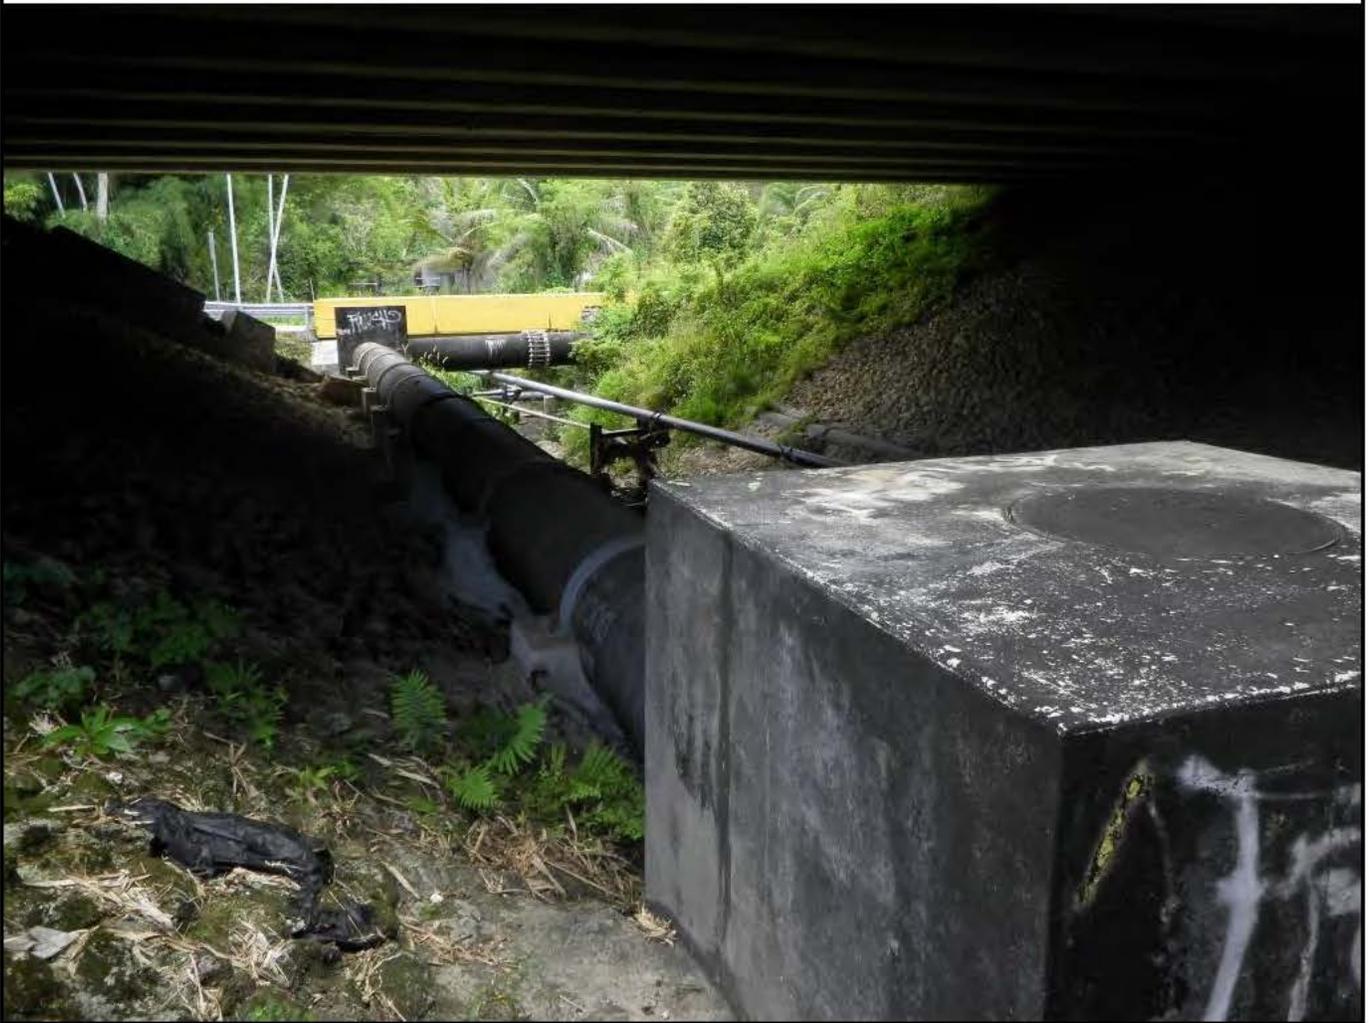
File Name: RIMG0076.JPG

Title	Guam Waterworks Authority (VP0989)
Subject	CWA Collection System
Date Time Stamp	4/30/2012 1:06:17 PM
Photographer	D. Vanlerberghe
Description	Incoming pipeline to New Chaot pump station.

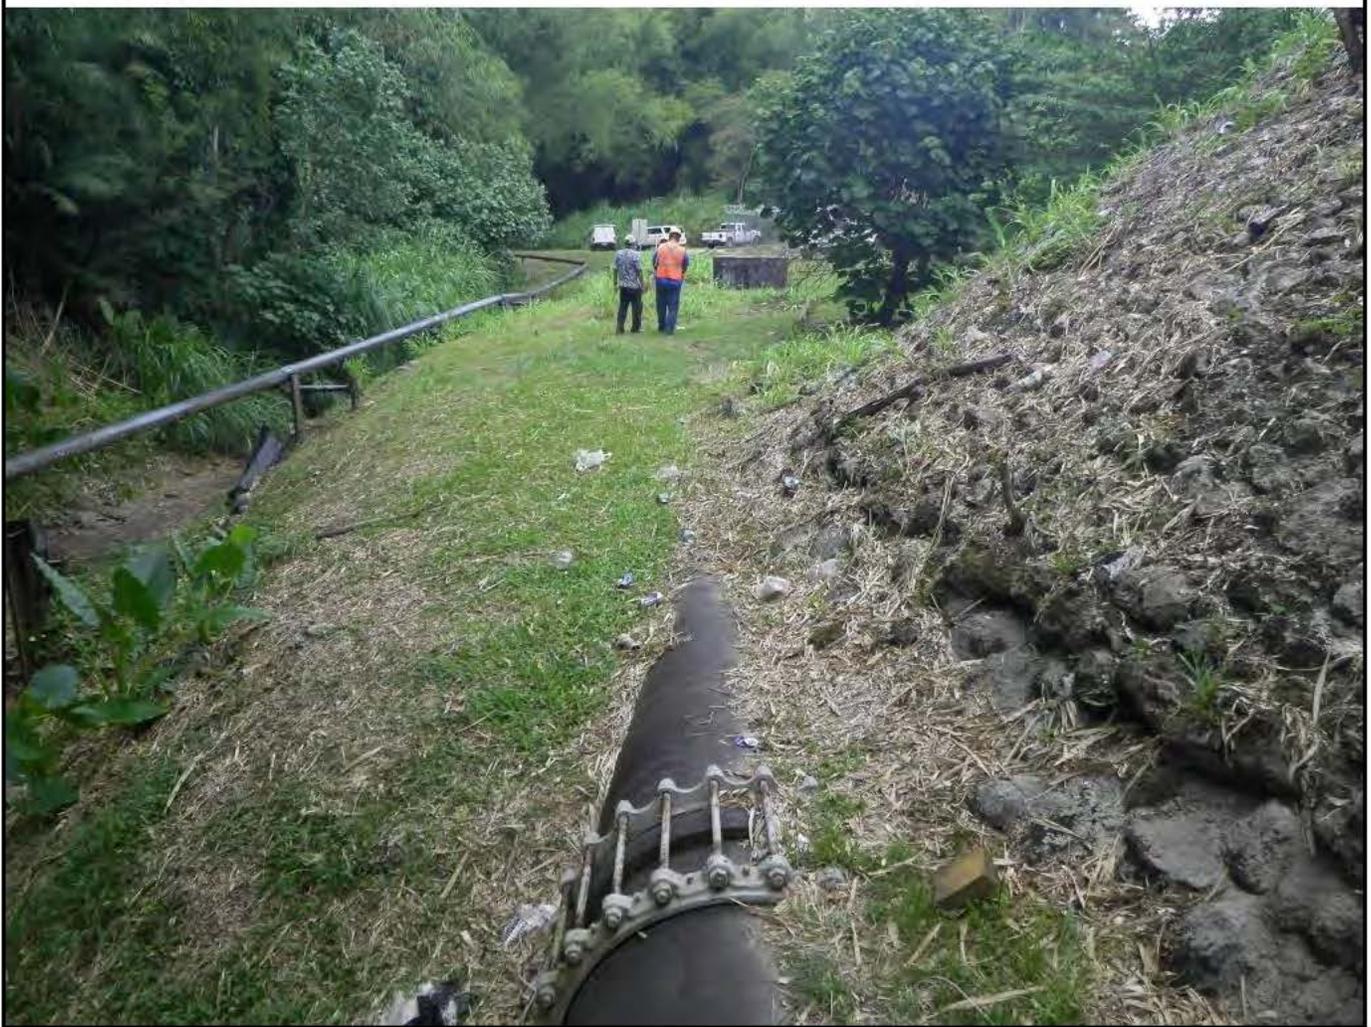
File Name: RIMG0077.JPG

Title	Guam Waterworks Authority (VP0989)
Subject	CWA Collection System
Date Time Stamp	4/30/2012 1:07:26 PM
Photographer	D. Vanlerberghe
Description	Incoming line to New Chaot pump station.

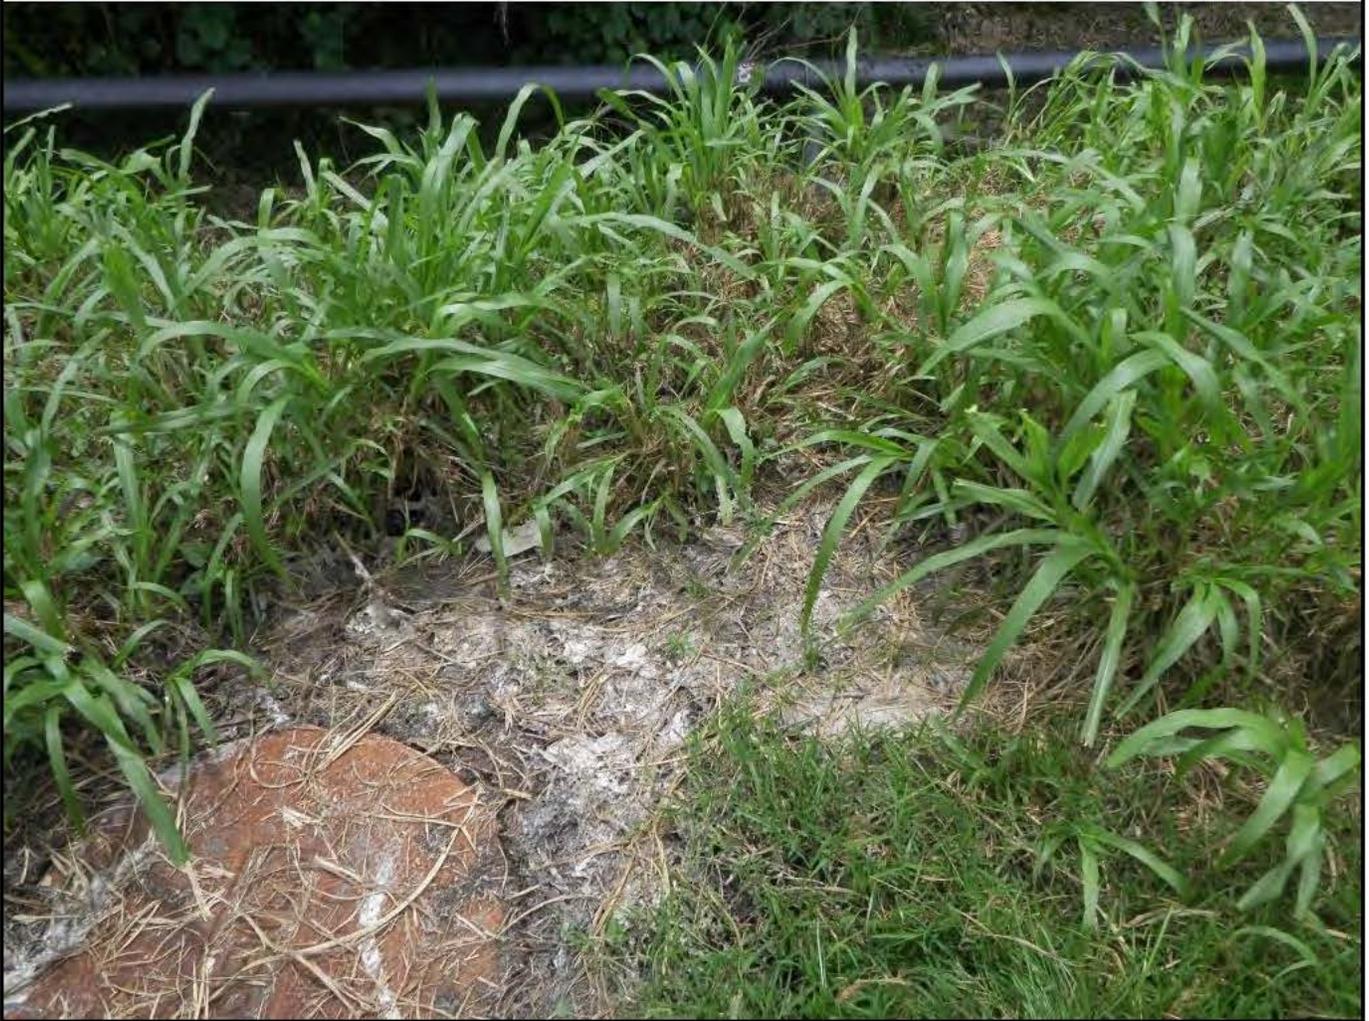
File Name: RIMG0078.JPG

<b>Title</b>	Guam Waterworks Authority (VP0989)
<b>Subject</b>	CWA Collection System
<b>Date Time Stamp</b>	4/30/2012 1:09:54 PM
<b>Photographer</b>	D. Vanlerberghe
<b>Description</b>	Manhole adjacent to New Chaot pump station and unnamed stream ditch on incoming pipeline to pump station. The manhole lid was open with sign of debris and overflow from the manhole towards the unnamed stream ditch.

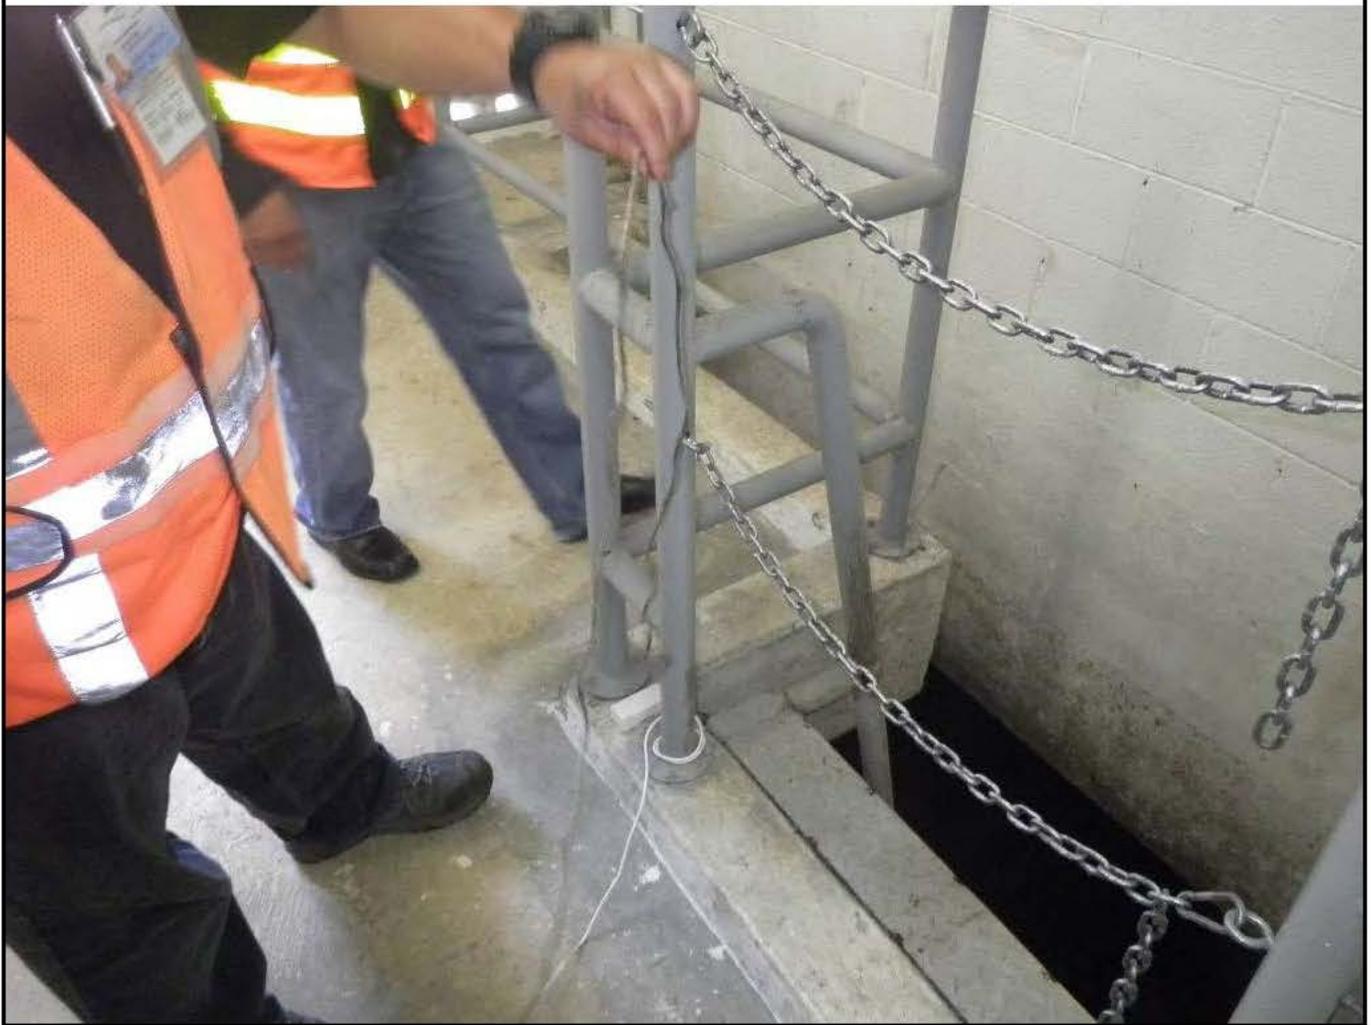
File Name: RIMG0079.JPG

Title	Guam Waterworks Authority (VP0989)
Subject	CWA Collection System
Date Time Stamp	4/30/2012 1:16:01 PM
Photographer	D. Vanlerberghe
Description	New Chaot pump station wet well level sensor.

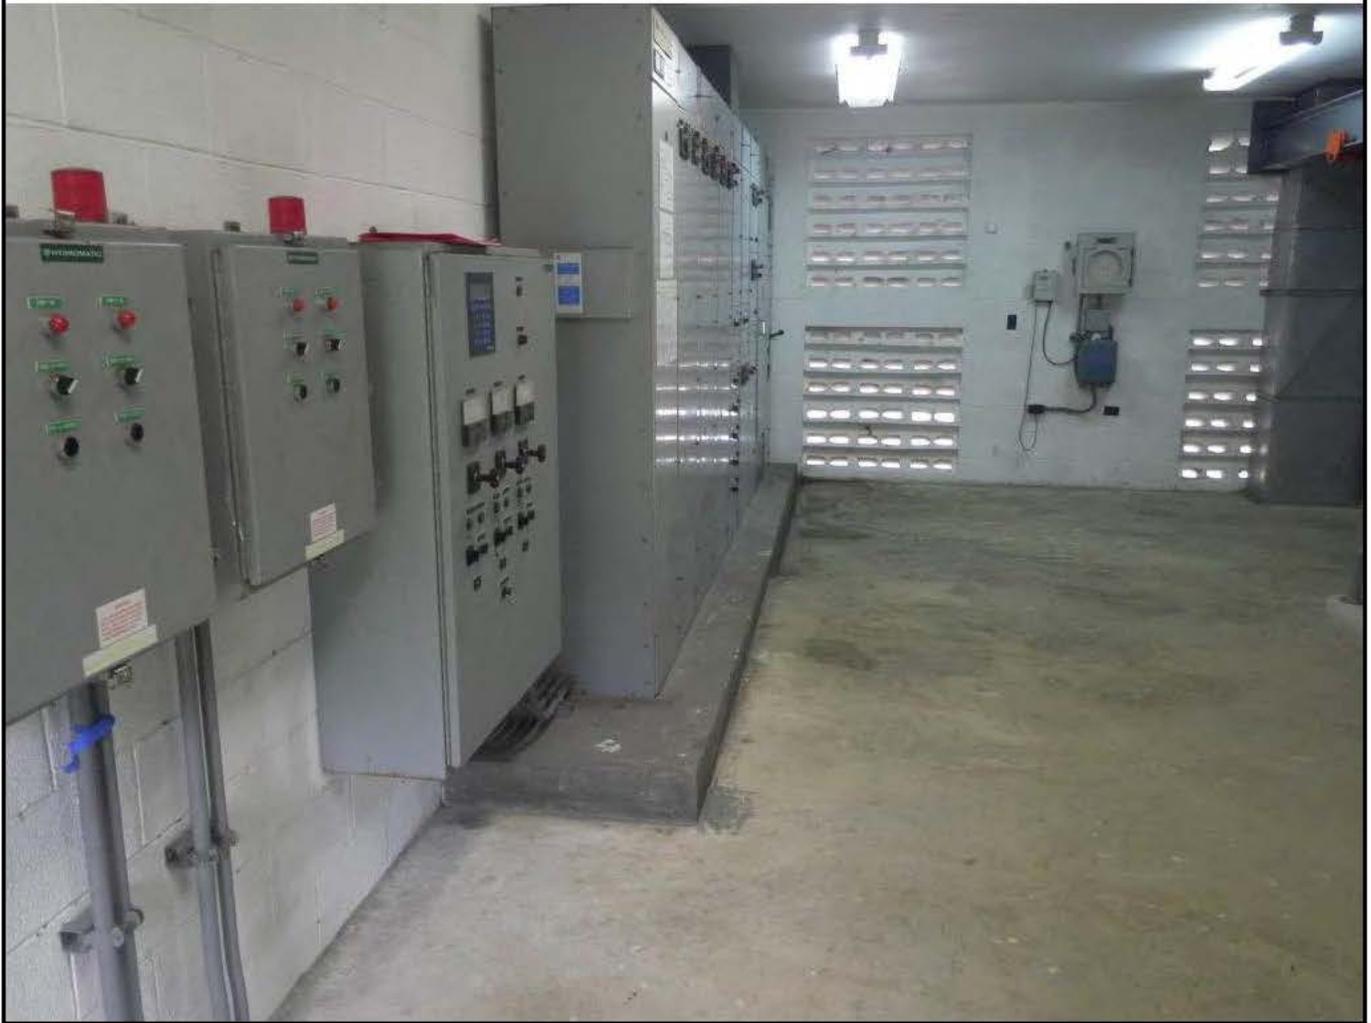
File Name: RIMG0080.JPG

Title	Guam Waterworks Authority (VP0989)
Subject	CWA Collection System
Date Time Stamp	4/30/2012 1:26:26 PM
Photographer	D. Vanlerberghe
Description	New Chaot pump station pump control room.

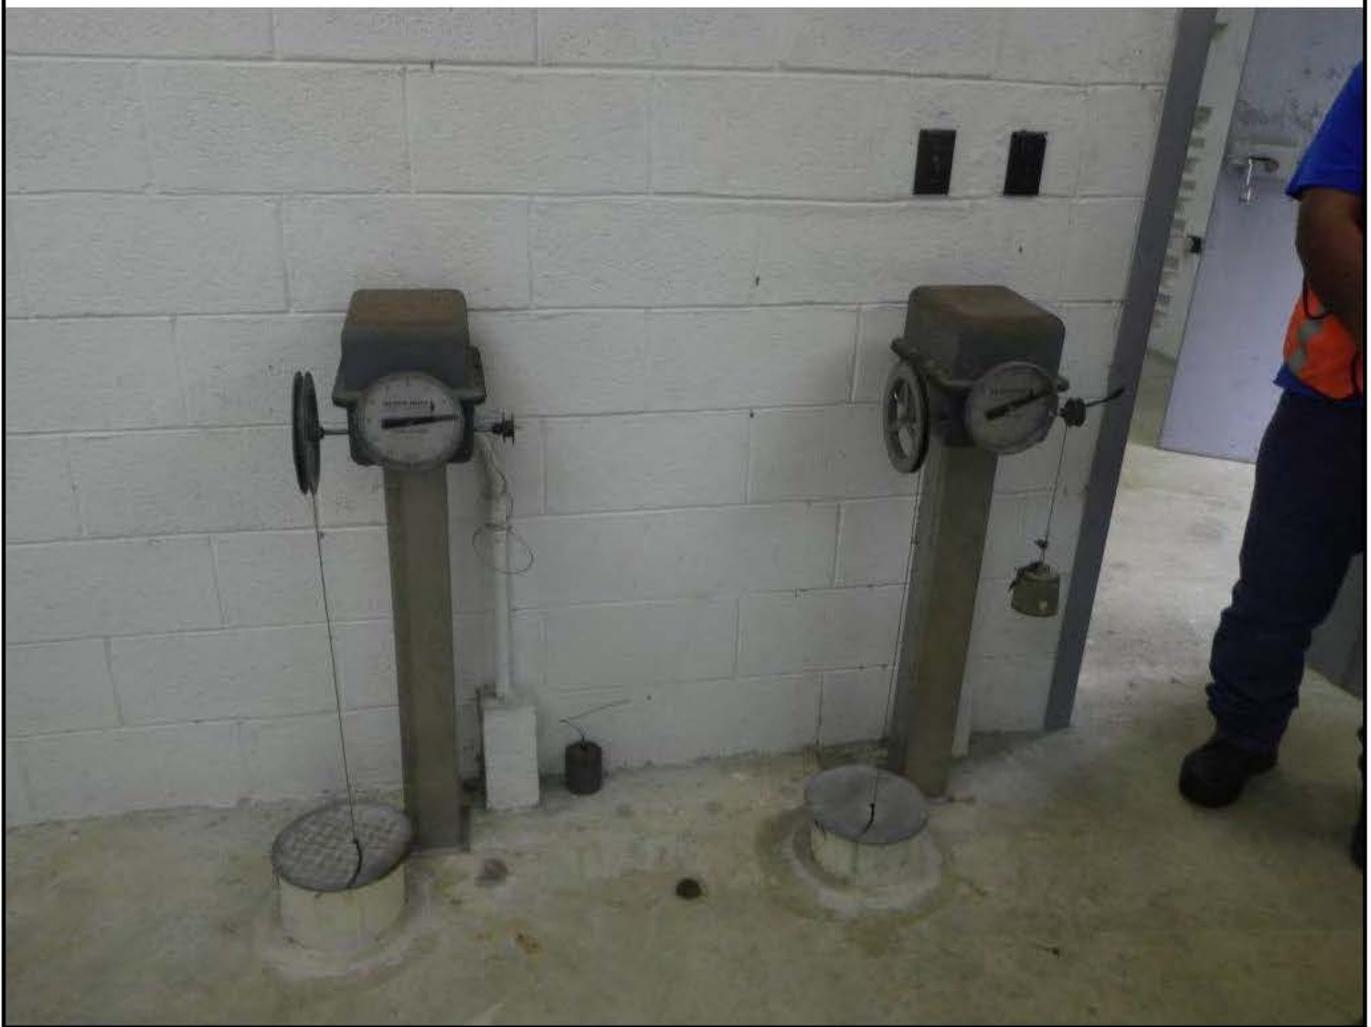
File Name: RIMG0081.JPG

Title	Guam Waterworks Authority (VP0989)
Subject	CWA Collection System
Date Time Stamp	4/30/2012 1:27:40 PM
Photographer	D. Vanlerberghe
Description	New Chaot pump station wet well level control floats
